RV INSPECTION CONNECTION

REPORT

123 Main Drive
VIN 4445555AAXXPPQQ

Travel Trailer and 5th Wheel Inspection Report

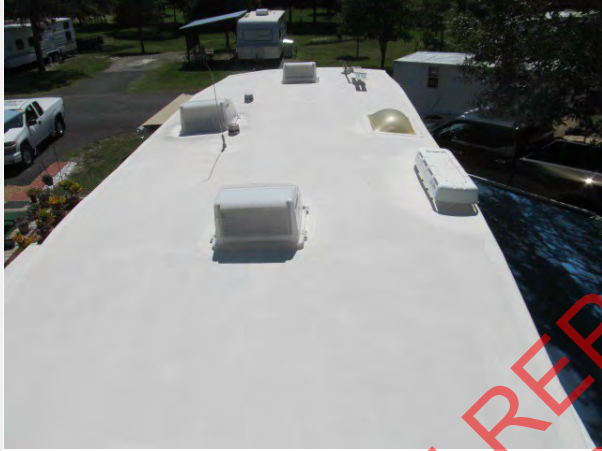
Roof Overview

General Condition of Roof: Acceptable

- Roof appears to have been recently coated and resealed.

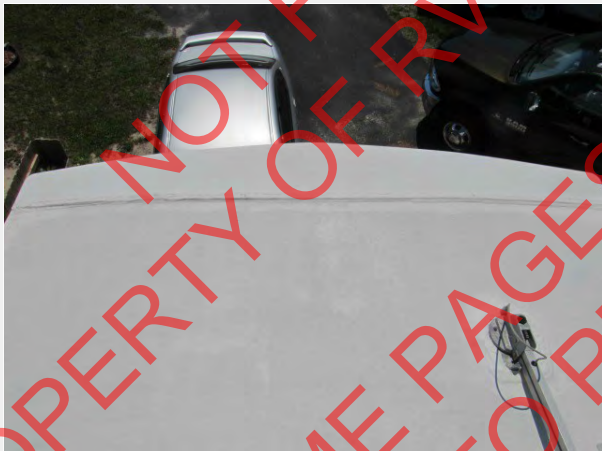
Front Cap/Joints and Seals

General Condition of Front Cap Assembly: Acceptable

- Front seal appears new.

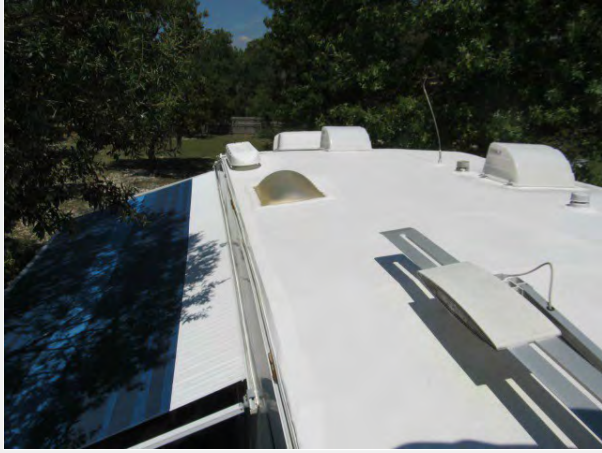
Awning Rail Trim - Curb Side

- Main awning rail trim in good condition.

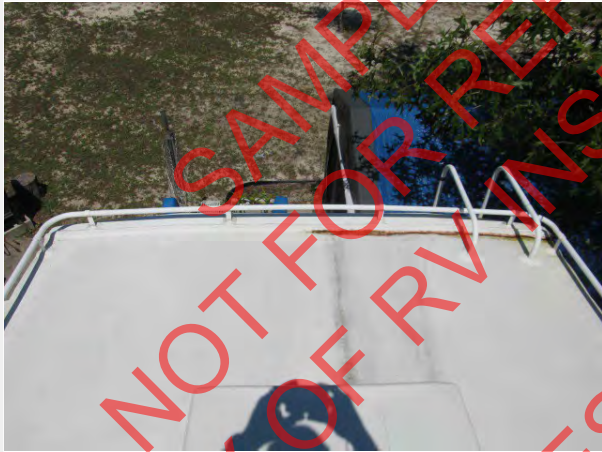
Rear Cap/Joint and Seals

General Condition of Rear Cap Assembly: Acceptable

- Rear seal appears new.

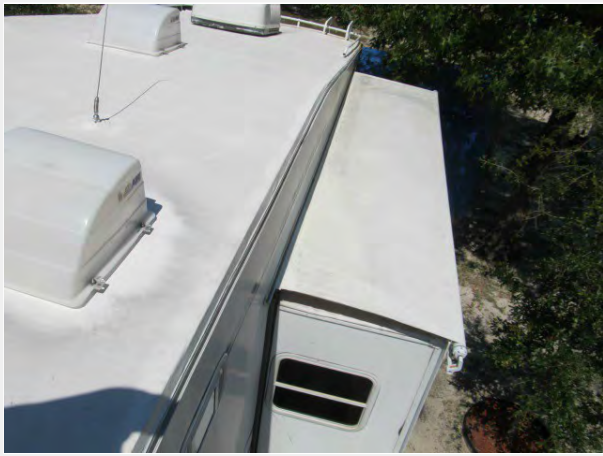
Trim Rail - Street Side

General Condition of Rail Trim - Street Side: Acceptable

- Street side trim rail in good condition.

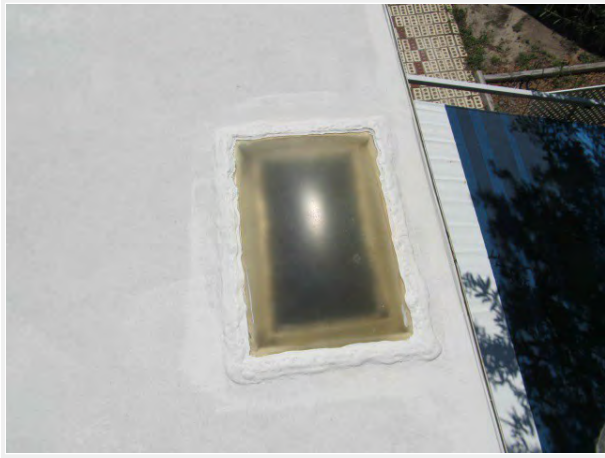
Roof Vents and Skylights

Skylight(s): 1 **Condition:** Fair

- All vent covers clean and in good condition. Skylight shows its age.

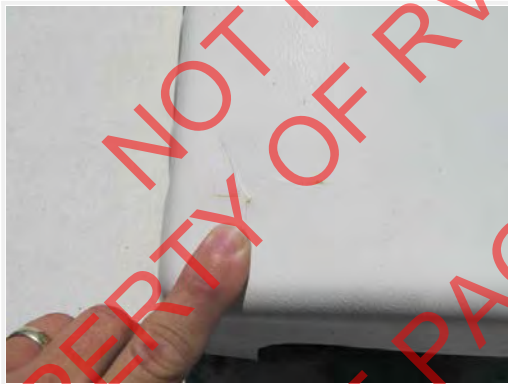
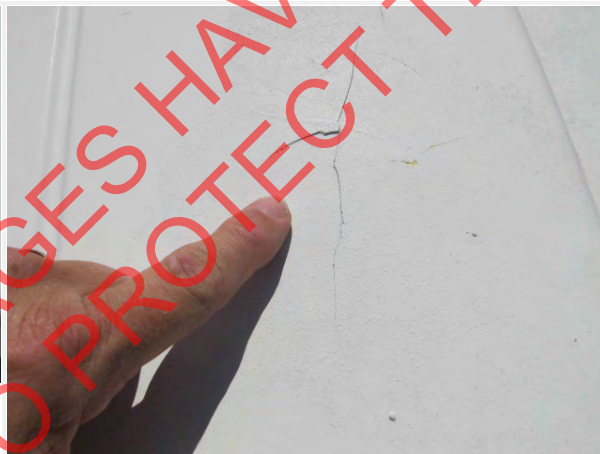
Air Conditioner #1

Air Conditioner Shroud: Fair

AC Exterior Coils - Condition: Fair

- AC cover has 2 cracks. Coils show hail damage and need to be straightened.

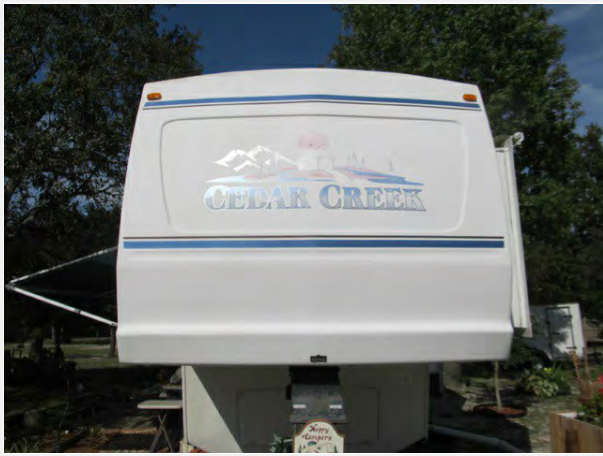
Front Cap/Wall

General Condition of Paint and Decals: Fair

- Front decals show their age. Cap is in good condition.

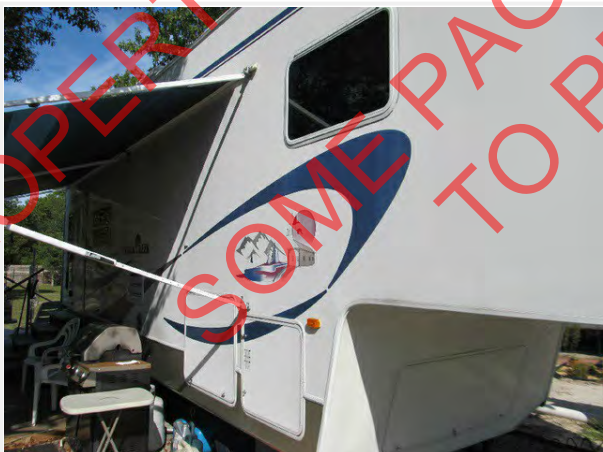
Curb Side - Side Wall

General Condition of Paint and Decals: Fair

- Wall in good condition. Decals not under awning showing age.

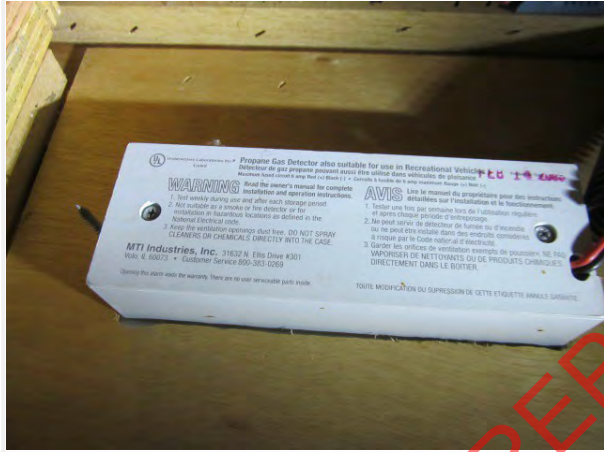
Date of Mfgr.: Feb 2003

Did LP Detector go into Alarm during test: Yes - Unit went into alarm

- Propane cylinders are within 1 year of requiring re-certification. LP detector worked, but is overdue replacement.

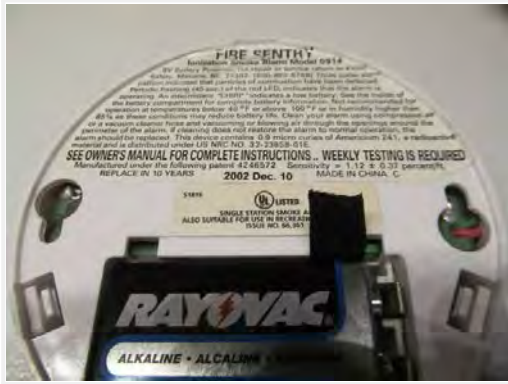
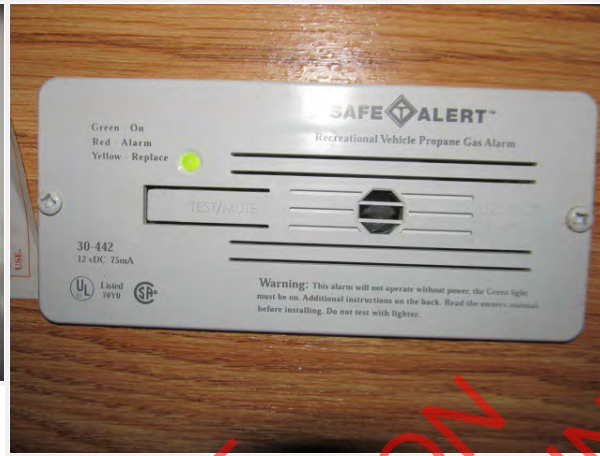
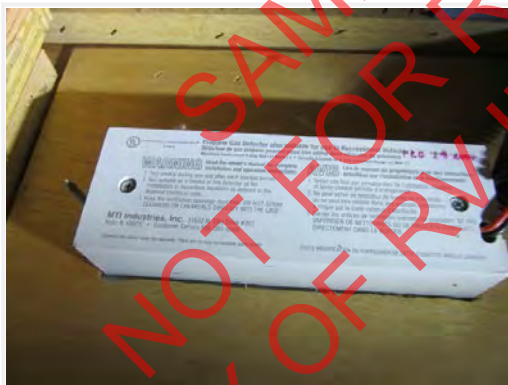
CO Monitor and Smoke Detector Testing

Did CO Detector go into Alarm during test: No - Unit did not go into alarm

Date of Mfgr.: Dec 2002

- Both detectors functioned, but are overdue replacement.

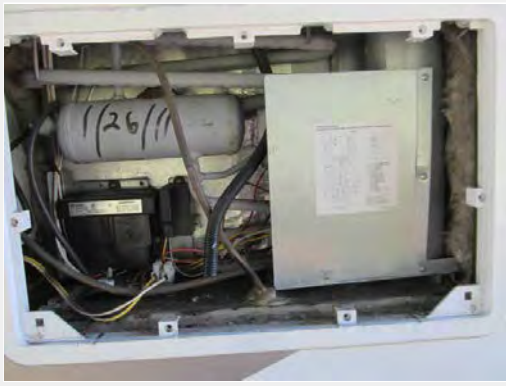
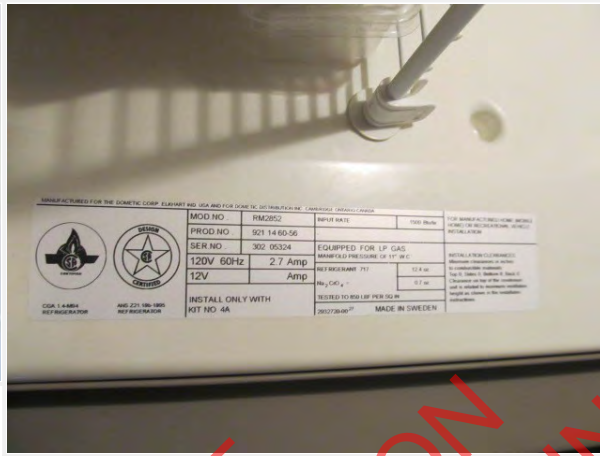
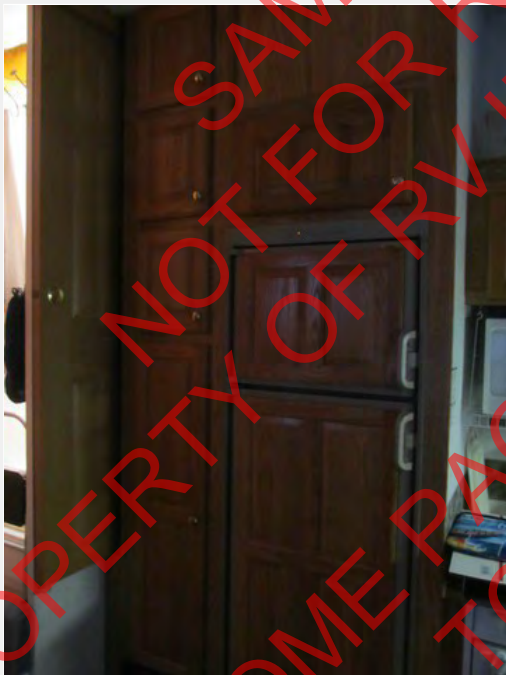
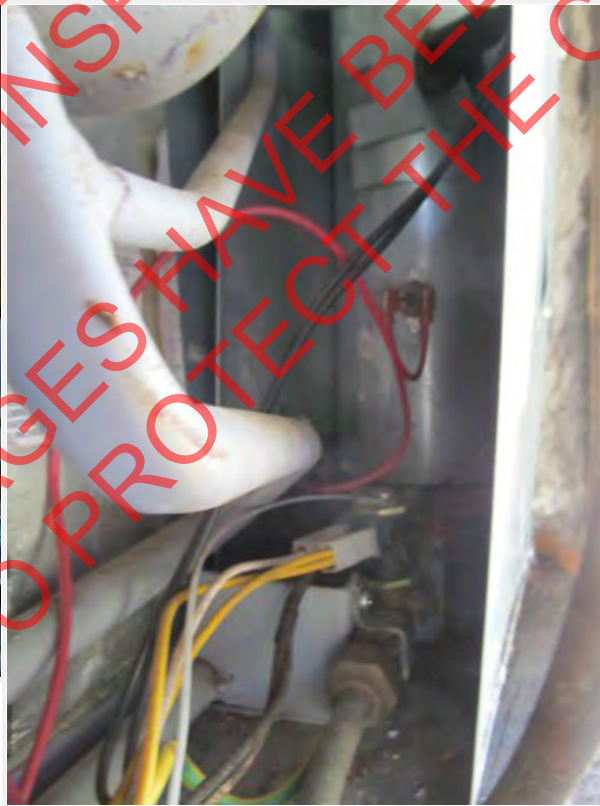
Refrigerator

Condition of Cooling Coils: No Visible Indication of Leaking Refrigerate

Has a Recall Kit been installed: Yes

- o Refrigerator/freezer functions correctly. Per owner, cooling section had been replaced 3 years ago due to ammonia leak. Recall kit installed at that time.
