RV INSPECTION CONNECTION

REPORT

COMPLETED ON
7/16/2014

MOTOR HOME INSPECTED
123 Main Drive
VIN 1112222333344455

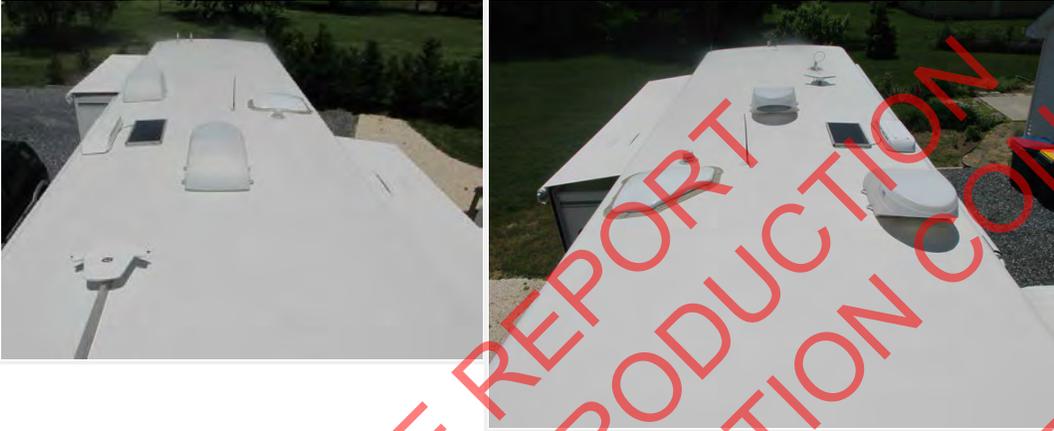
Roof Overview

General Condition of Roof: Acceptable

- Exterior - Roof/Roof overview: all OK

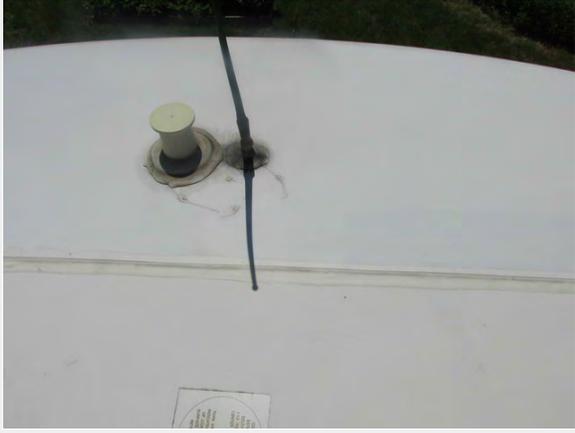
Awning Rail Trim - Curb Side

- Exterior - Roof/Awning Rail Trim/Curb Side: all OK

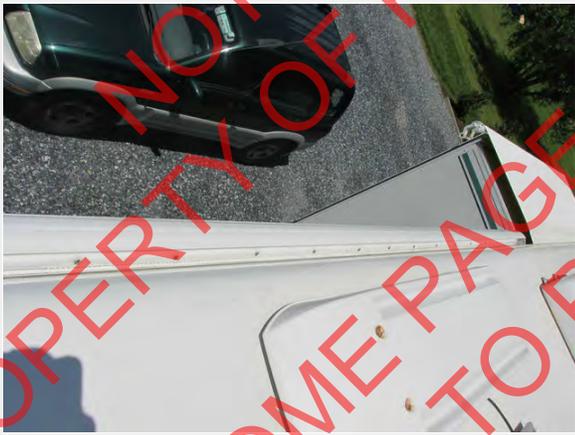
Rear Cap/Joints and Seals

- Exterior - Roof/Roof/Rear Cap: all OK

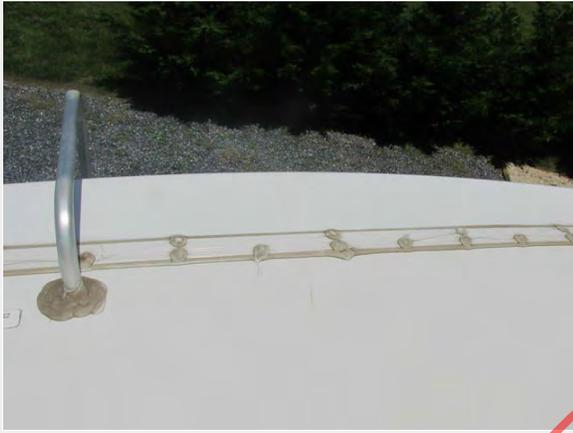
Trim Rail - Street Side

- Exterior - Roof/Trim Rail/Street Side: all OK

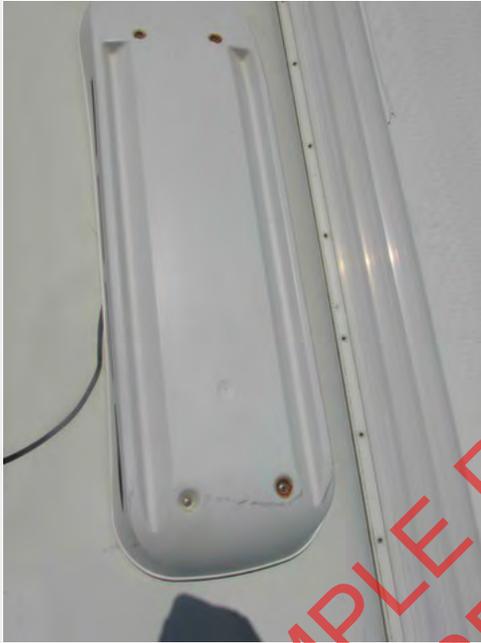
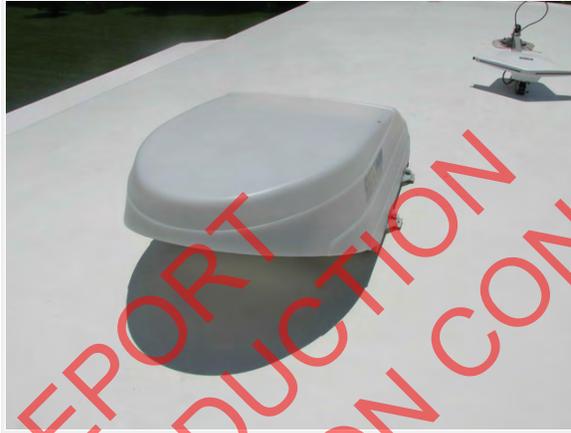
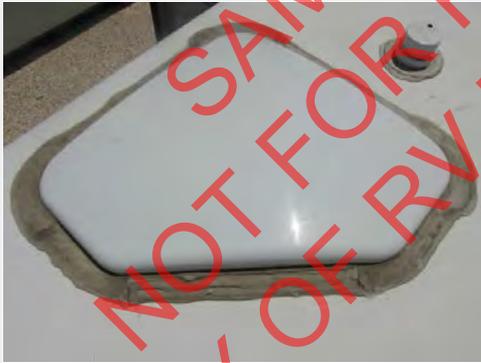
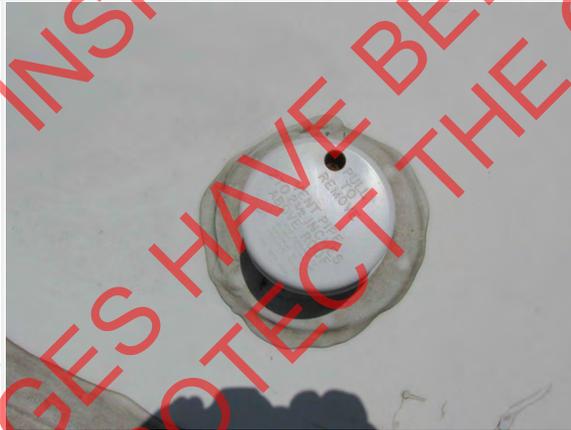
Roof Vents and Skylights

- Exterior - Roof/Roof Vents & Skylight: all OK

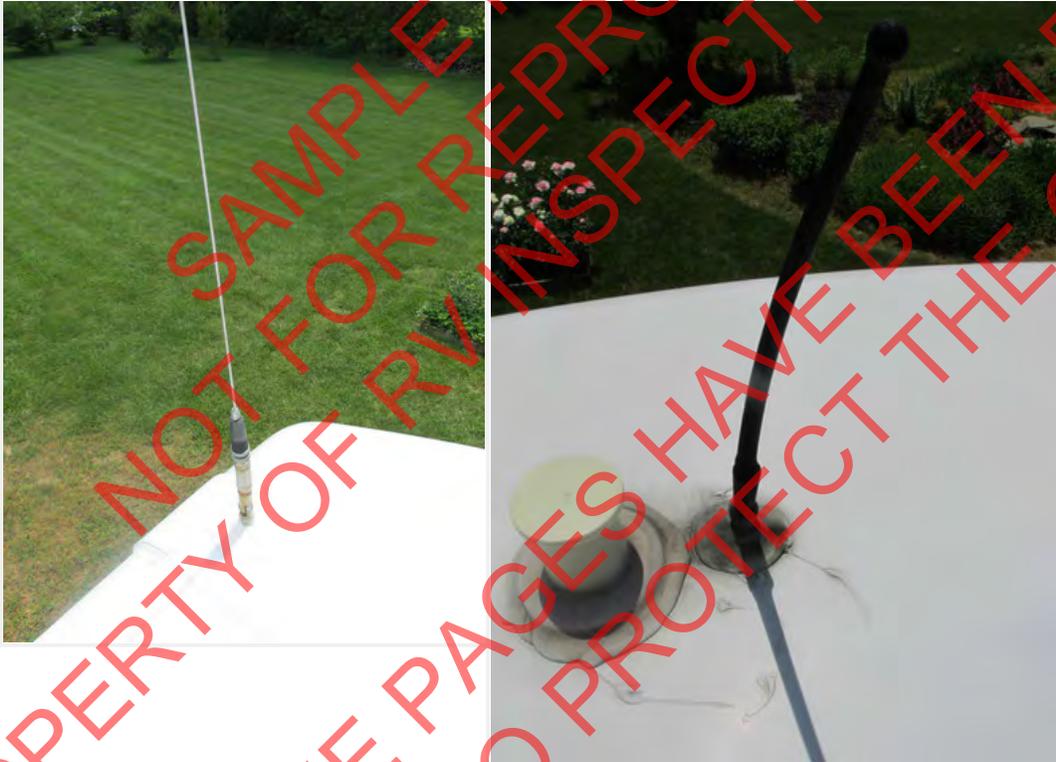
- Exterior - Roof/Roof Accessories: 2 radio antennae, CB antenna on roof, functioning; awning wind sensor, not functioning.

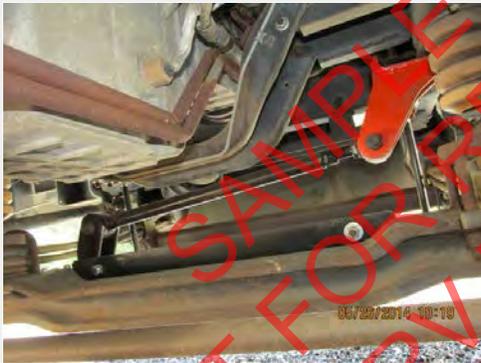
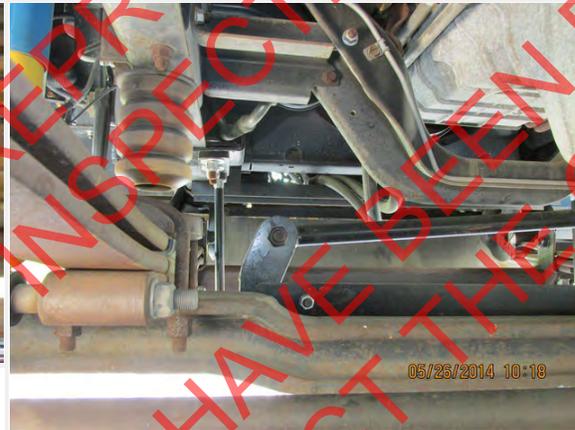
Chassis and Undercarriage Overall Condition

General Overall Condition of Chassis and Undercarriage: Fair

Signs of Rust: Yes

- Exterior - Chassis - Undercarriage/Chassis/Undercarriage/Chassis and Undercarriage Overall Condition: No unusual conditions or signs of damage.

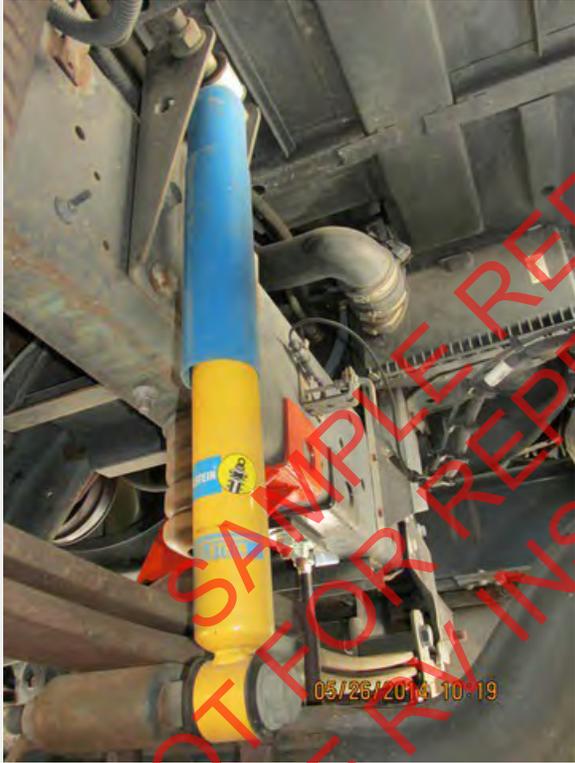
- o Exterior - Chassis - Undercarriage/Steering Components: Shocks replaced June 2013.

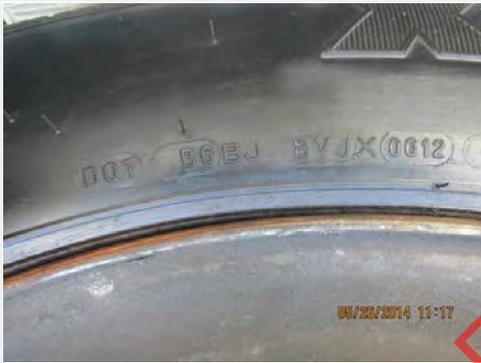
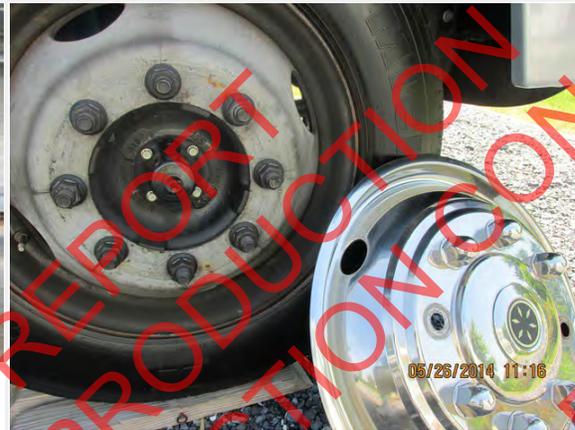
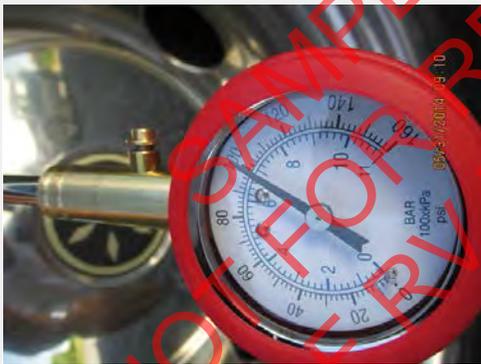
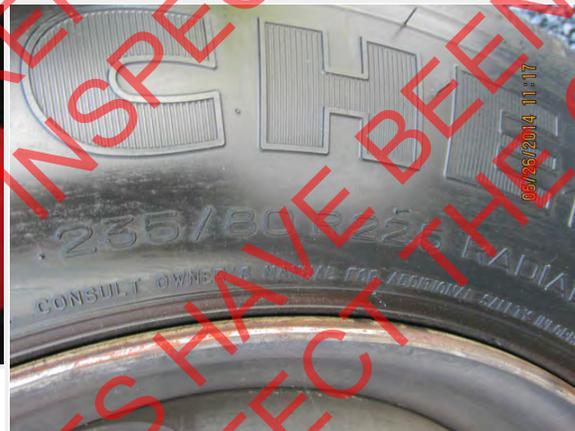
Front Wheel Assembly

- o Exterior - Chassis - Undercarriage/Front Wheel Assembly: Front axle Tire Assembly OK.

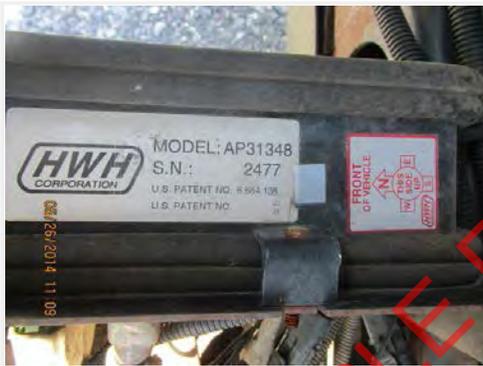
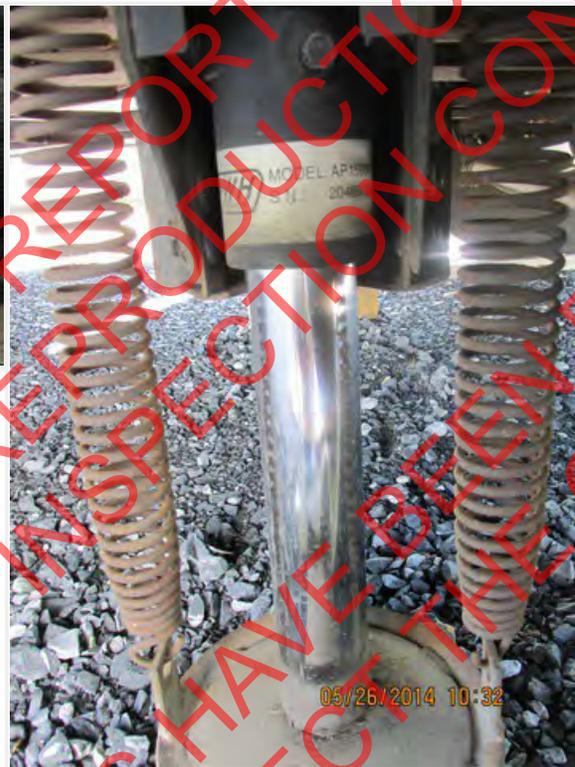
- o Exterior - Chassis - Undercarriage/Leveling System: jacks OK

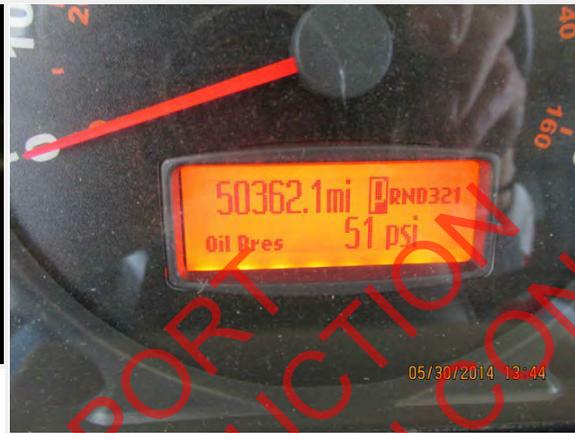
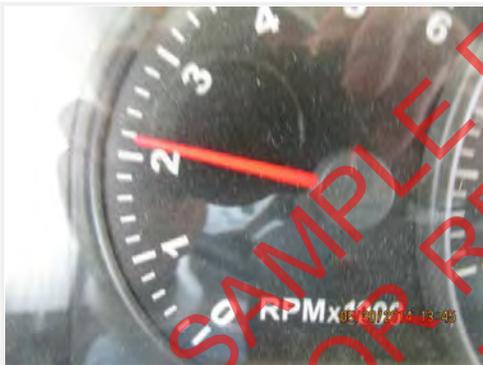
- o Exterior - Chassis - Undercarriage/Engine: All Engine items OK.

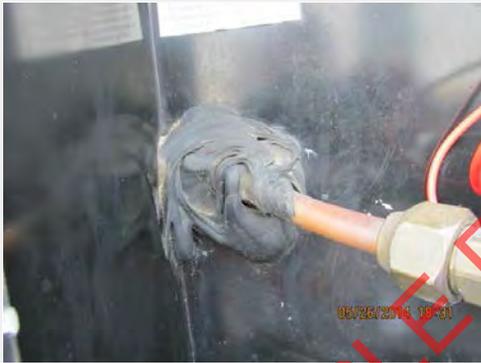
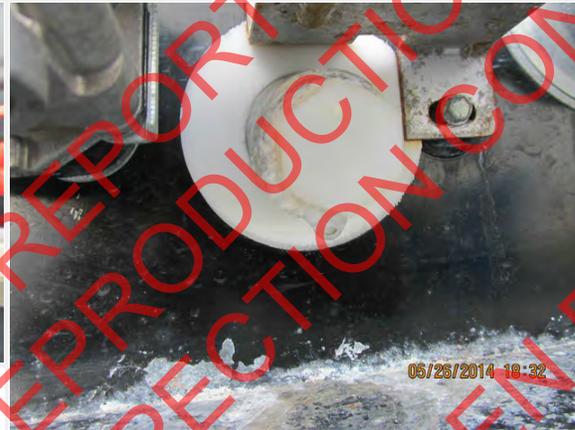
Indication of Water Leaks: Yes

- o Appliances/Water Heater: drain plug appears to be leaking.

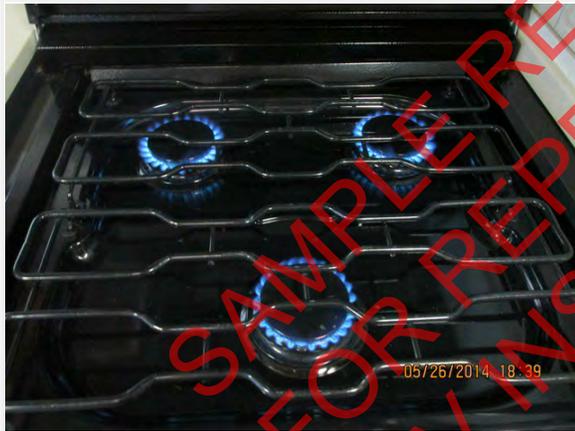
- o Appliances/Cook Top - Oven: No Oven. All OK with Cook Top.

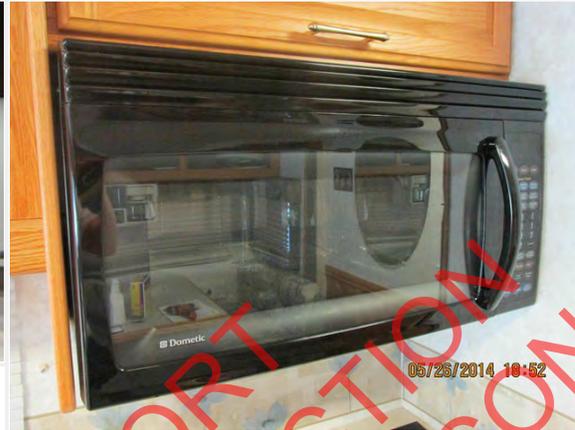
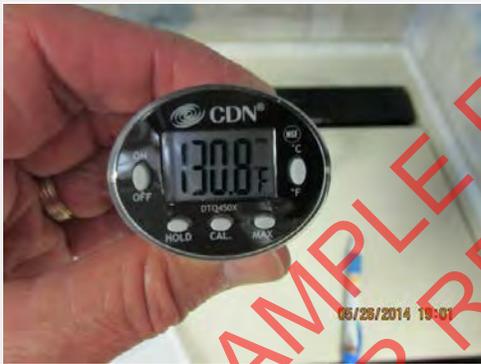
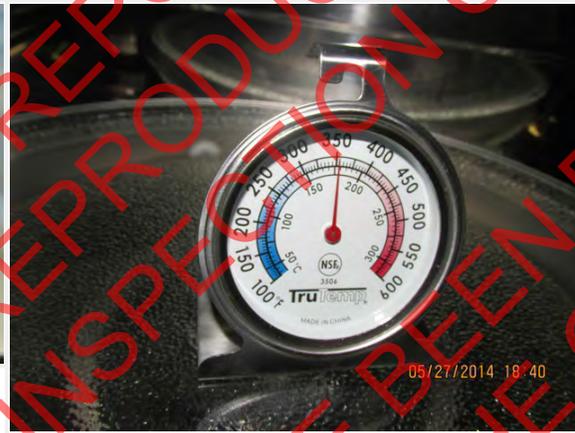
- o Appliances/Microwave: This Dometic Microwave/Convection Oven installed December 2013, replacing original Sharp unit.
- Appliances/Microwave: On Convection Oven mode, oven heated to 350 degrees when pre-heat was set for 375.

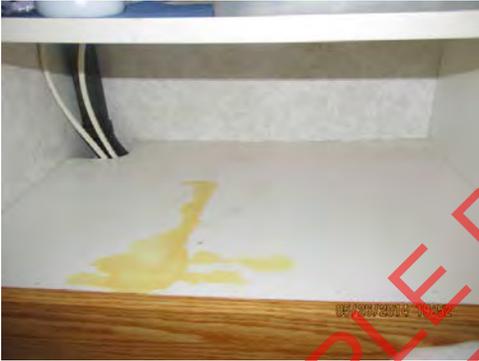
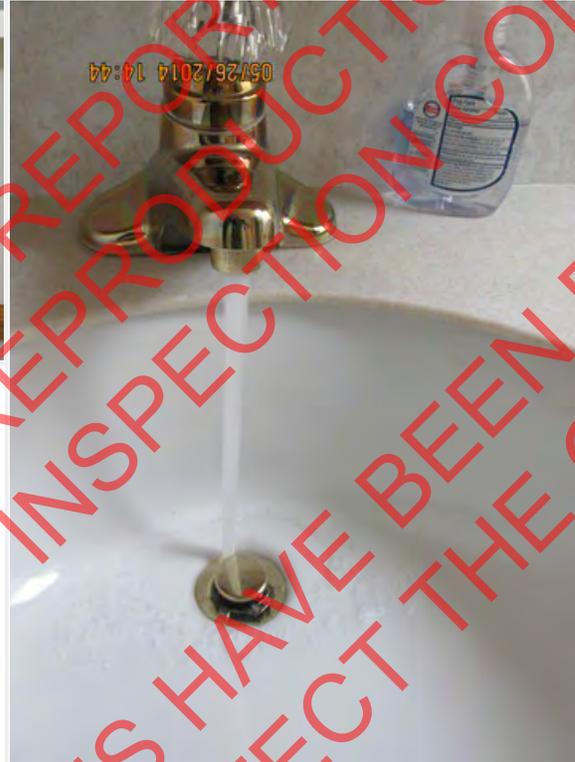
- o Interior Conditions and Appearance/Bathroom Sink and Faucet: Small stain area around drain. Stain on lower shelf of cabinet, underneath, from leaking cleaning product, not from a water leak.

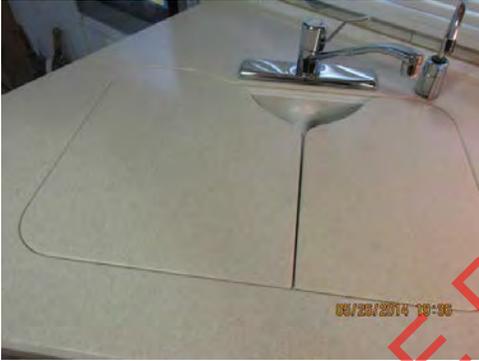
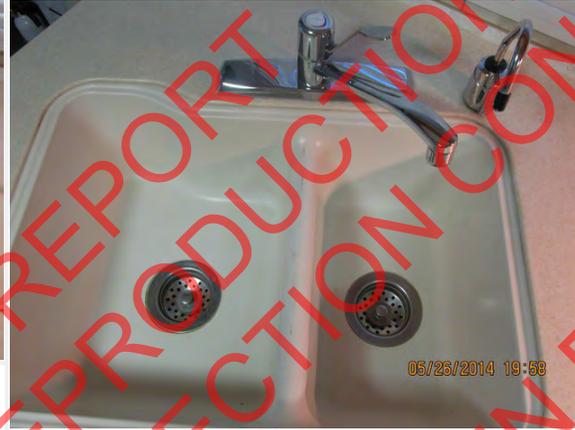
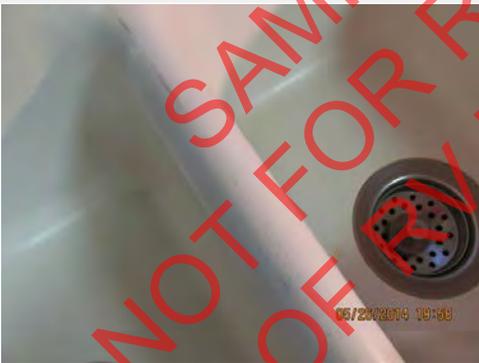
Kitchen Sink / Faucet

General Overall Condition of Kitchen Sink / Faucet: Fair - Stains and Mineral Deposits are Present

- o Interior Conditions and Appearance/Kitchen Sink and faucet: Kitchen Sink has some staining.

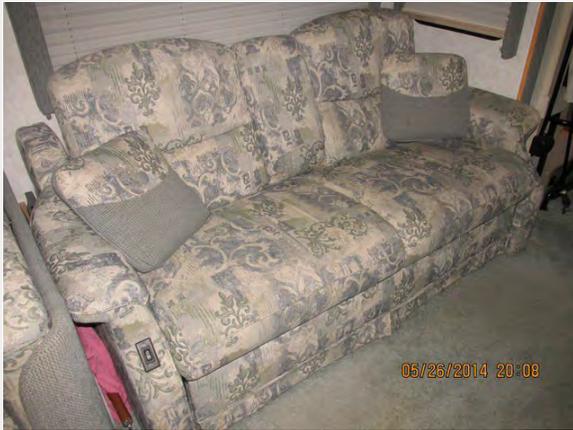
- o Furniture Condition/Sofa: Sofa electrically reclines to queen-sized bed, and it functions properly.

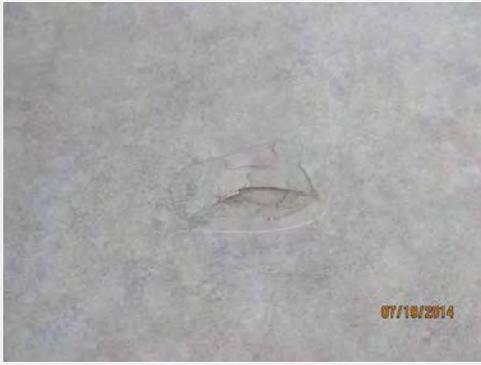
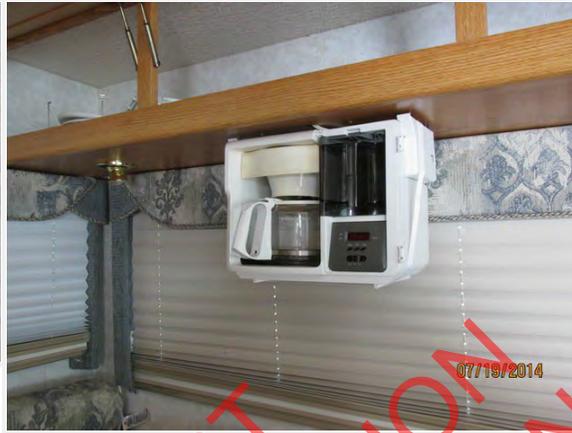
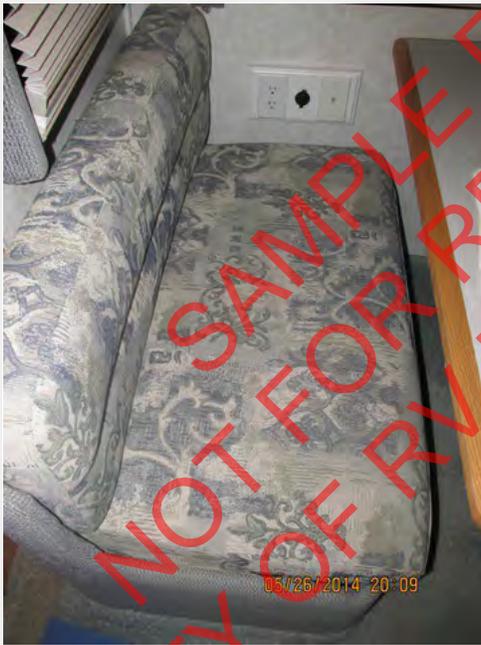
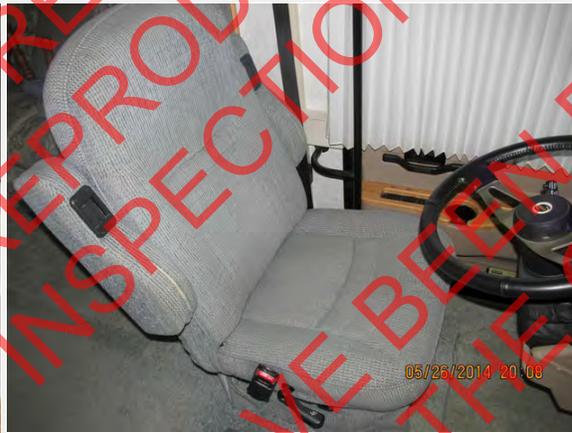
Dinette/Table/Chairs

- o Furniture Condition/Dinette/Table/Chairs: Dinette table surface damaged.

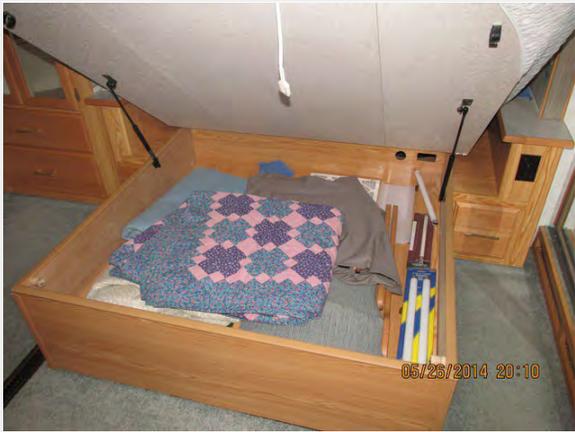
- o Furniture Condition/Bed: Original bed cover and pillow shams not being used, stored. See above, under Sofa, re: it's also a queen-size bed.
