RV INSPECTION CONNECTION

REPORT

COMPLETED ON
7/16/2014

MOTOR HOME INSPECTED
123 Main Drive
VIN 1112222333344455

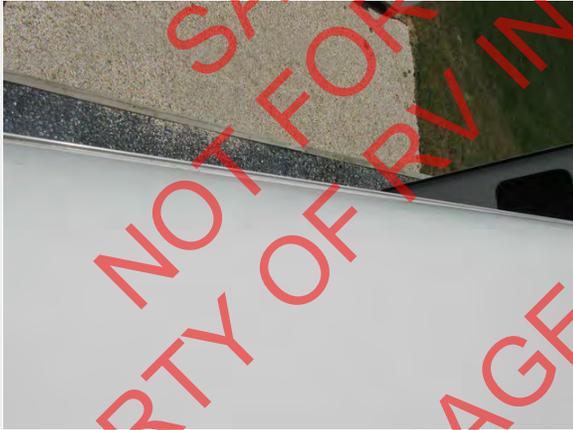
Trim Rail - Street Side Specifics

- Exterior - Roof/Trim Rail/Street Side: all OK

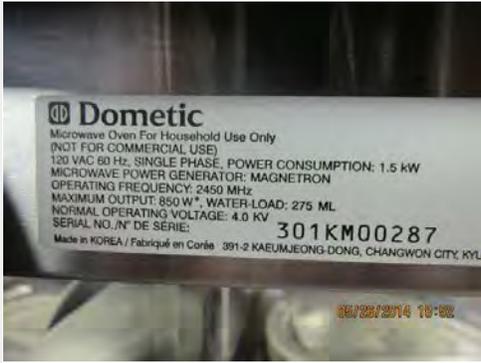
- o Appliances/Microwave: This Dometic Microwave/Convection Oven installed December 2013, replacing original Sharp unit.
- Appliances/Microwave: On Convection Oven mode, oven heated to 350 degrees when pre-heat was set for 375.

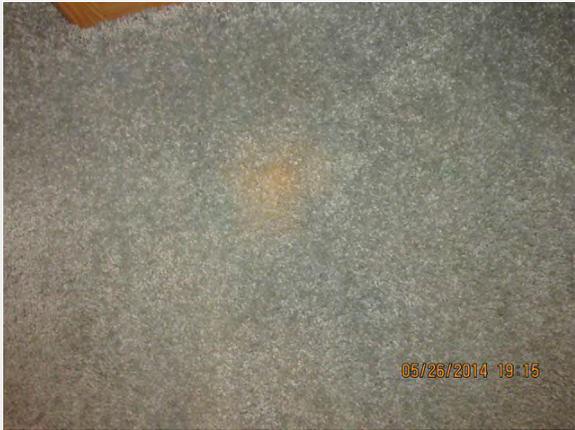
- o Interior Conditions and Appearance/Flooring: Vinyl tile present, good condition. Carpet stain in front of couch and in bedroom area below street side window.

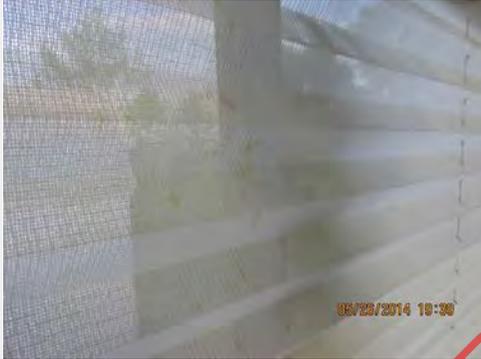
o Interior Conditions and Appearance/Blinds and Shades: Day/Night shade strings have been replaced numerous times. Shade adjacent to dinette has stains.

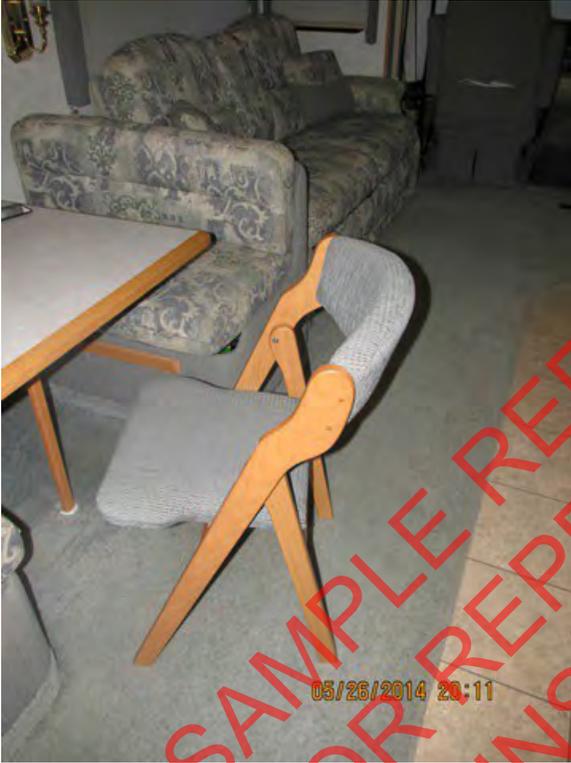
- o Furniture Condition/Chairs: Swivel Recliner/Rocker original equipment has been removed; only Chair is an original equipment folding chair to place at the end of the dinette, and is stored under the bed.
